**Kenney Cottage
Berkeley, CA**

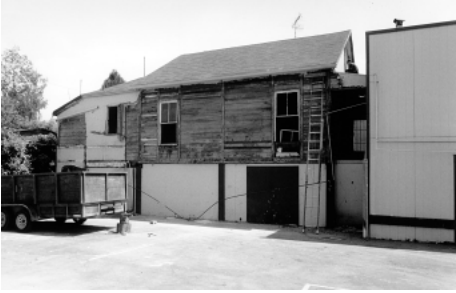
<p data-bbox="396 632 516 663">Photo1.jpg</p>	4/2002	View of the west wall of Kenney Cottage, looking northeast. When Kenney Cottage was moved to University Avenue in 1906, it was elevated and storage rooms were built below the dwelling. The portion of the building located behind the trailer is a non-historic addition.

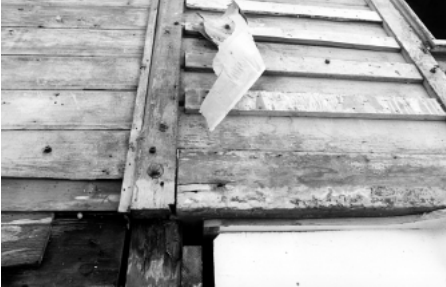
<p data-bbox="396 997 516 1029">Photo2.jpg</p>	4/2002	Detail view of the bolted sill and corner post connection (to the left of center). The siding to the left of the corner post is cladding on the addition, and the recessed siding to the right of the corner post is original to Kenney Cottage.

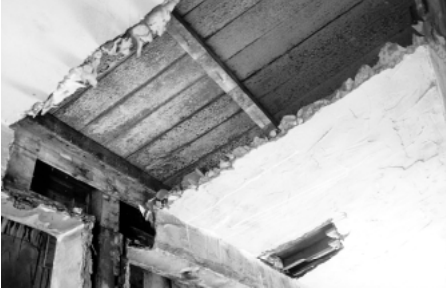
<p data-bbox="396 1362 516 1394">Photo3.jpg</p>	4/2002	Detail view of one of the original porch posts at the left and the porch ceiling above. This historic fabric was encased in stucco and uncovered during the process of documenting the building.

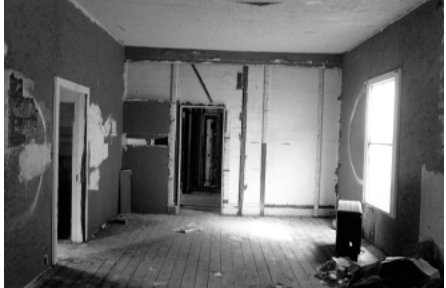
<p data-bbox="396 1728 516 1759">Photo4.jpg</p>	4/2002	View of the main room in Kenney Cottage, looking north toward the rear wing. Selective demolition of non-historic wall finishes revealed that this room was originally divided into two smaller rooms and exposed the post and board construction at the back wall.

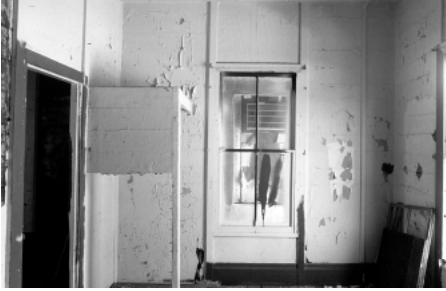
<p>Photo5.jpg</p>	4/2002	View of the post and board construction in the south, first floor bedroom and one of the original two-over-two light windows.

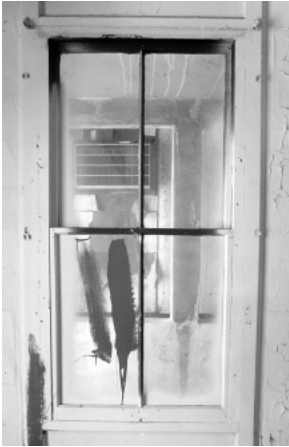
<p>Photo6.jpg</p>	4/2002	Detail view of one of the original two-over-two light windows, set between two of the posts that make up the post and board wall construction.
